CATHODIC PROTECTION SYSTEMS
INSTALLED ON SUBSTRUCTURE SURFACES

CA-92-02
03-NEV-80 PM 59.44
03-377601
Yuba Pass Overhead and Separation
Bridge No. 17-231/R

FINAL REPORT
DECEMBER 1995

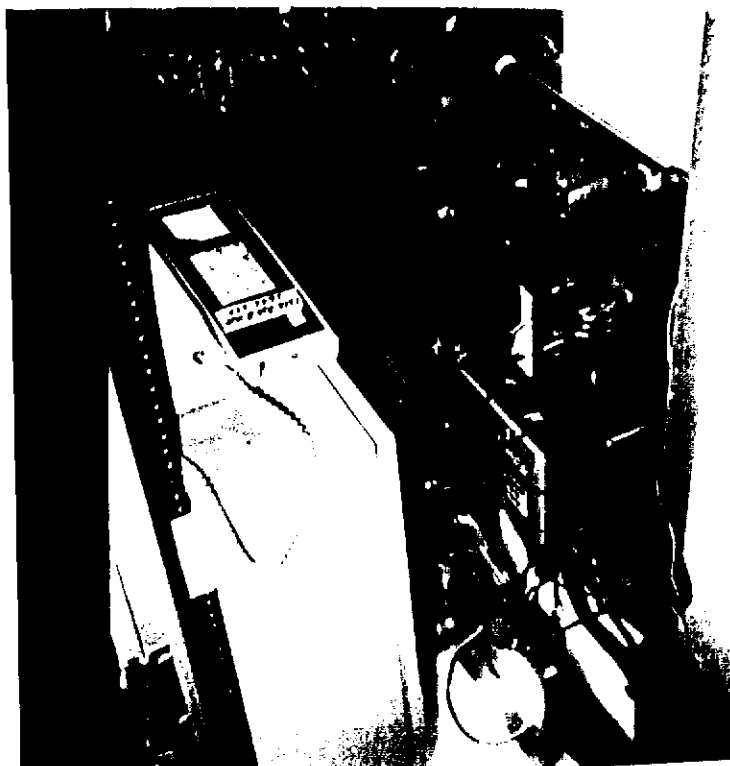
Figure 19. Close up view inside the CP control cabinet showing the CP system components.

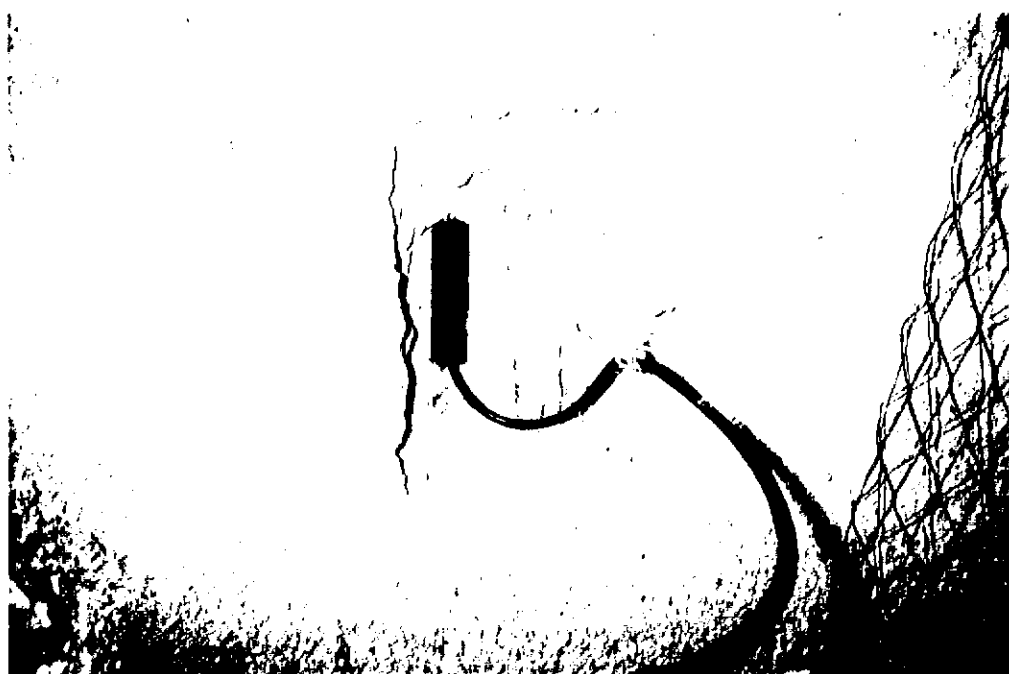
Figure 20. View of a graphite reference cell. The reference cells were grouted in-place next to the reinforcing steel. The reference cells will be used to monitor the electrical potential of the reinforcing steel. This will give an indication of the level of protection provided to the steel.

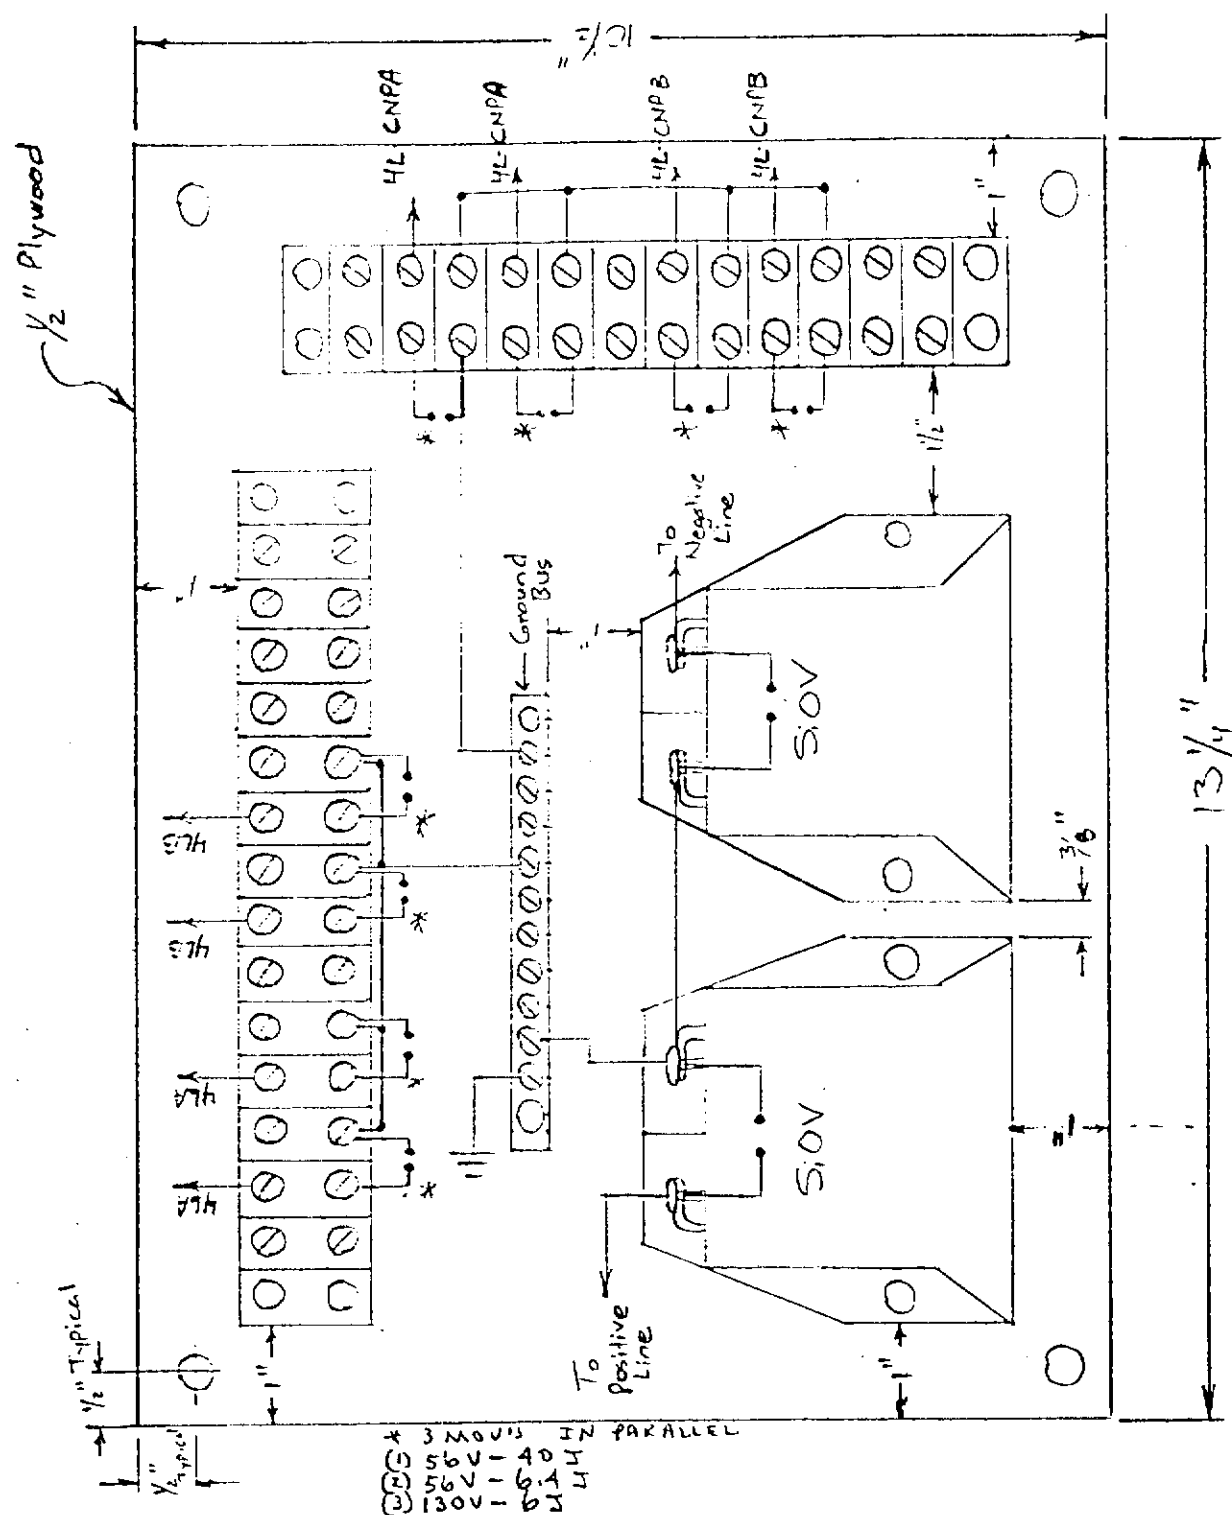
Figure 27. Schematic diagram of metal oxide varistor (MOV) board used for lightning protection of the power leads, reference cell leads, and corrosion null probe leads to Bent 4L (Elgard CP system). The MOV's provide a shunt to ground if large spikes or surges occur due to electrical storms. Three MOV's with different energy level ratings were used in parallel to protect against a wide range of electrical and/or surges. The board was mounted at the CP control cabinet.

On March 10, 1994 lightning damaged the Campbell datalogger and the Metallized Zinc CP rectifier. The CP rectifiers had DC lightning protection devices across the positive and negative rectifier output leads and an AC lightning protection device across the AC power input lines to the CP system. The electrical ground for the CP systems as originally connected was provided through a third wire ground lead connection (from the AC power input lines) to an existing ground rod for the nearby Caltrans fuel and maintenance work building located approximately 90 meters (300 feet) from the rectifier location.

Repairs were made to the damaged components and additional lightning protection devices were added after reviewing the latest available literature regarding lightning protection for electrical components and consulting with members of the Caltrans Electrical and Commodities Testing Section. Metal oxide varistors (MOV's) were added to all input and output lines of the Elgard and Metallized Zinc CP systems for additional lightning protection. These devices provide a shunt to ground if large transient spikes or surges occur in the CP system wiring and components during storm events. MOV's with different energy ratings were stacked in parallel on input and output lines of the CP systems to provide lightning protection against a wide range of transient responses. Figures 27 through 29 are schematic diagrams that show the added MOV's.

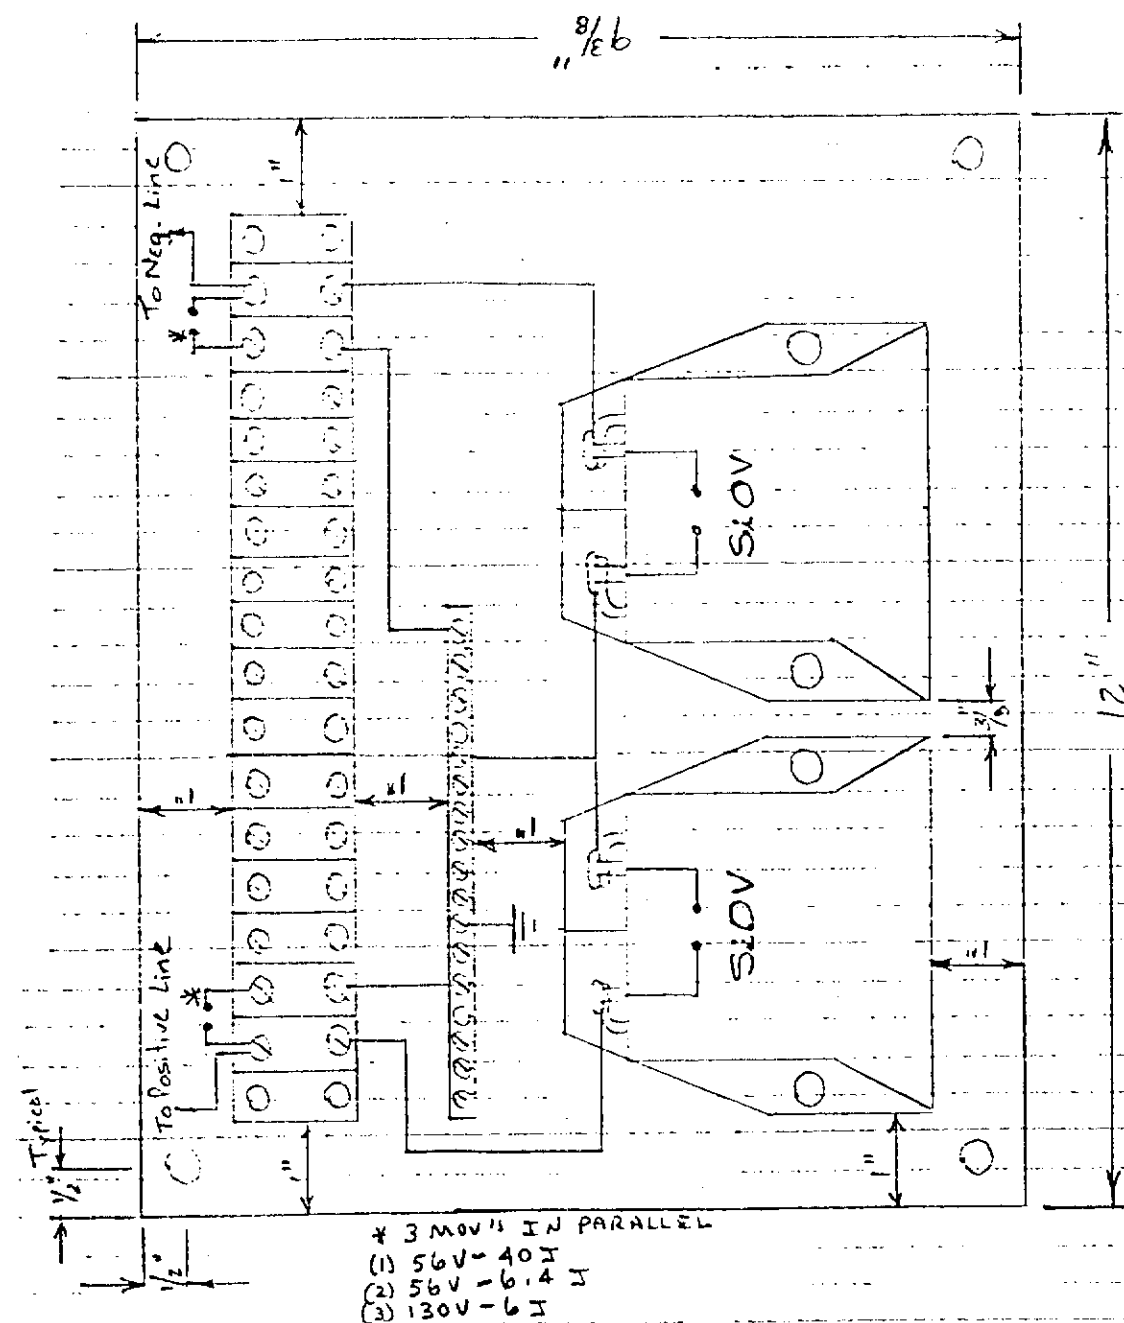
Figure 28. Schematic diagram of metal oxide varistor (MOV) board used for lightning protection of the power supply leads to Bent 4R (Metallized Zinc CP system). The MOV's provide a shunt to ground if large spikes or surges occur in the wiring due to electrical storms. Three MOV's with different energy level ratings were used in parallel to protect against a wide range of electrical spiking and/or surges. The board was mounted in a pull box at Abutment 5R. This location provided the shortest path to ground if electric charge is collected on the metallized zinc surface during an electrical storm event.

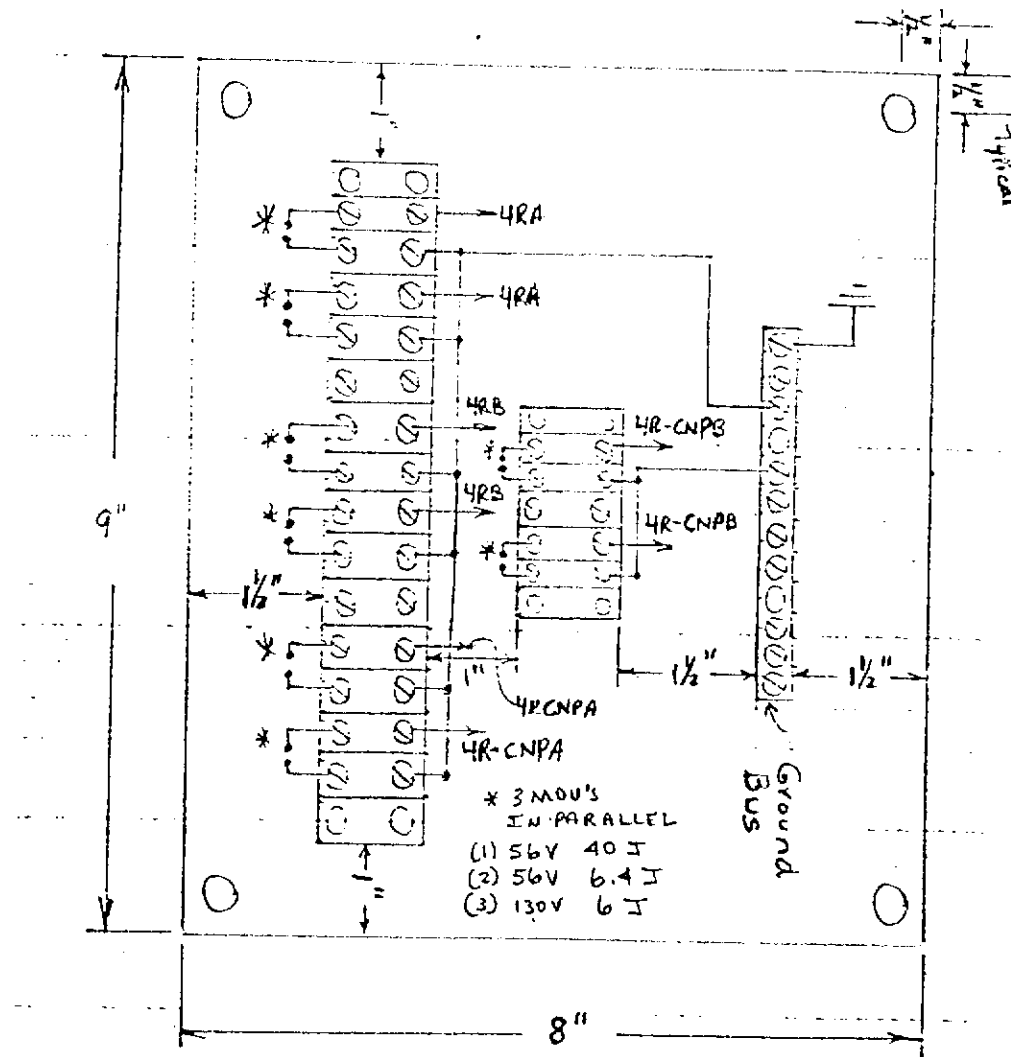
Figure 29. Schematic diagram of metal oxide varistor (MOV) board used for lightning protection of the reference cell leads and corrosion null probe leads to Bent 4R (Metallized Zinc CP system). The MOV's provide a shunt to ground if large spikes or surges occur due to electrical storms. Three MOV's with different energy level ratings were used in parallel to protect against a wide range of electrical spiking and/or surges. The board was mounted in a pull box at Abutment 5R. This location provided the shortest path to ground if electric charge collected on the metallized zinc surface during an electrical storm event.
